Evaluation of the Tailings Dam, Cyanide Use and Water Consumption at the Proposed Volta Grande Gold Project, Pará, Northern Brazil

Steven H. Emerman, Ph.D., Malach Consulting, LLC, 785 N 200 W, Spanish Fork, Utah 84660, USA, Tel: 1-801-921-1228, E-mail: SHEmerman@gmail.com

Report written at the request of Amazon Watch, submitted June 1, 2020

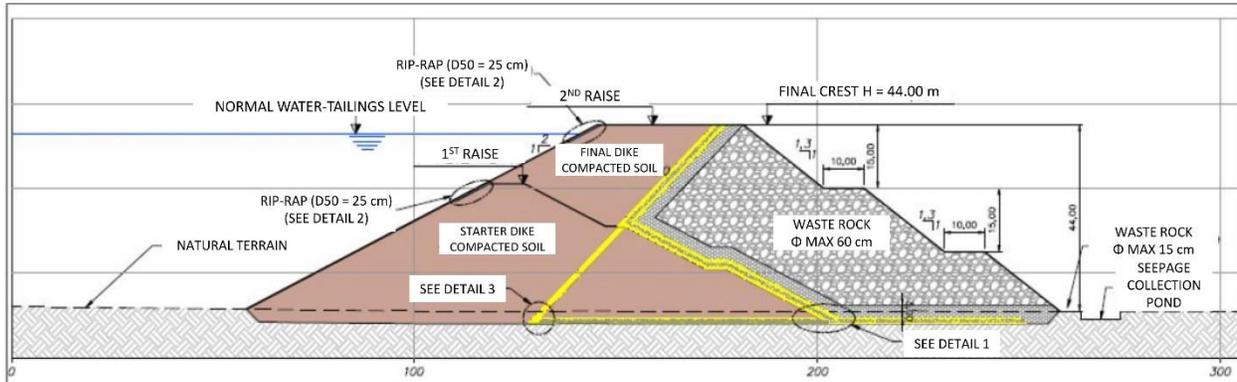
Figure 8. The tailings dam for the proposed Volta Grande Gold Project would be constructed in two raises using the downstream method (see Fig. 6b), with a final height of 44 meters. The starter dike would be constructed out of compacted soil, while the final dike would be constructed out of compacted soil on the upstream side and mine waste rock on the downstream side. Although the downstream method is the safest of the three most common construction methods, the additional security probably does not counterbalance the additional risk created by the excessive amount of water that would be stored behind the dam. The yellow lines indicate the internal drainage system. Figure from VOGBR (2016a) overlain with English labels.

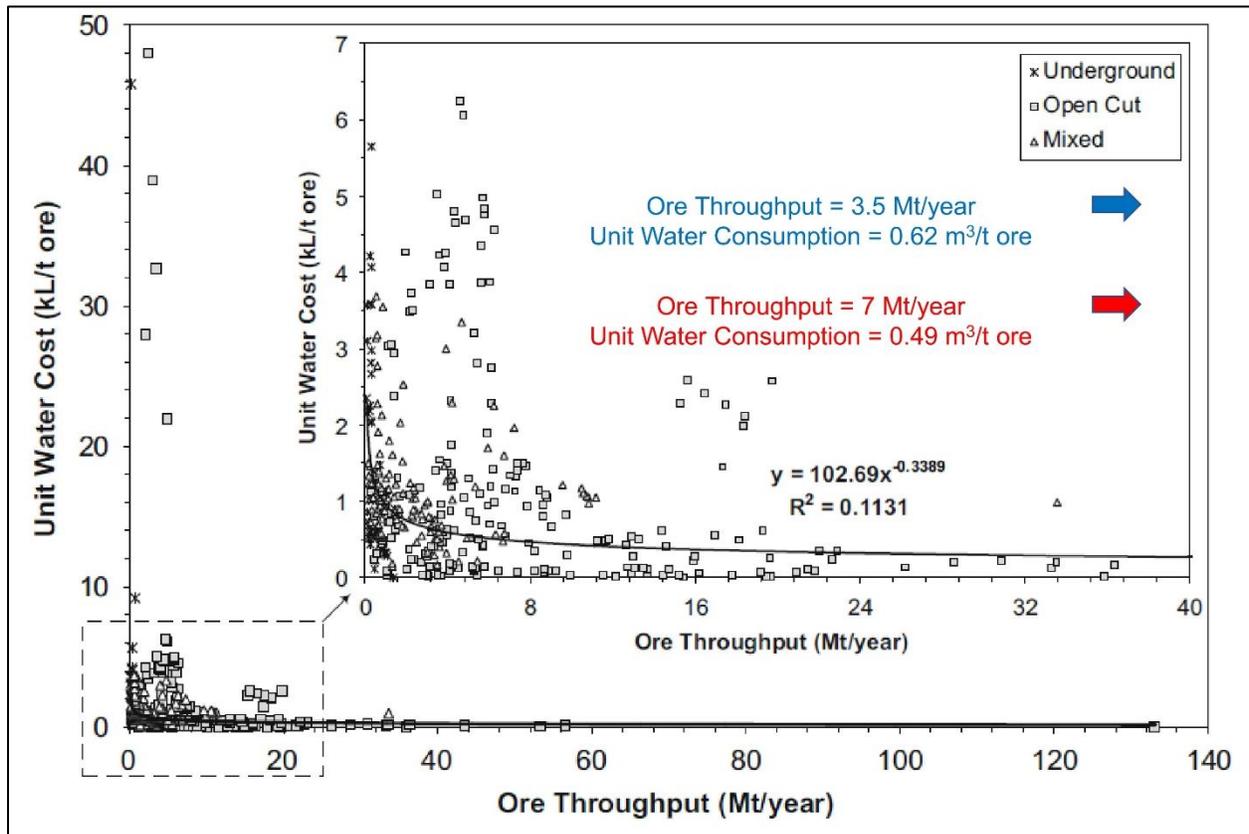
Figure 9. Brandt Meio Ambiente (2016a) estimated the water consumption of the proposed Volta Grande Gold Project to be 261.9 cubic meters per hour for an ore production rate of 3.5 million metric tons per year, corresponding to 0.655 cubic meters of water per metric ton of ore (see Table 2). The estimate is consistent with the best-fit curve for global gold mines (Mudd, 2010), which predicts unit water consumption of 0.62 cubic meters of water per metric ton of ore for the same ore production rate. By contrast, an earlier estimate for the proposed gold mine of 0.163 cubic meters of water per metric ton of ore for an annual ore production rate of 7 million metric tons (see Table 2; Chubb et al., 2015) would be much lower than the prediction based on global gold mines (0.49 cubic meters of water per metric ton of ore). Figure modified from Mudd (2010).

The predicted water consumption of the Volta Grande Project can also be compared with typical water consumption rates of gold mines as a function of ore throughput (Mudd, 2010). Although there is considerable scatter in the global data, marked improvements in water efficiency seem to occur for ore throughputs greater than about 3 million metric tons per year (see Fig. 9). For the ore production rate of the Volta Grande Project (3.5 million metric tons per year), the best-fit power-law curve to the global data predicts water consumption of 0.62 cubic meters of water per metric ton of ore (see Fig. 9), which is remarkably similar to the prediction for the Volta Grande Project (0.655 cubic meters of water per metric ton of ore). For the ore

production rate of the Phase II of the 2015 Feasibility Study (Chubb et al., 2015), the best-fit curve predicts water consumption of 0.49 cubic meters of water per metric ton of ore, which is again much greater than the earlier prediction. In summary, the predicted water consumption of the Volta Grande Project does not require any innovation in water efficiency.

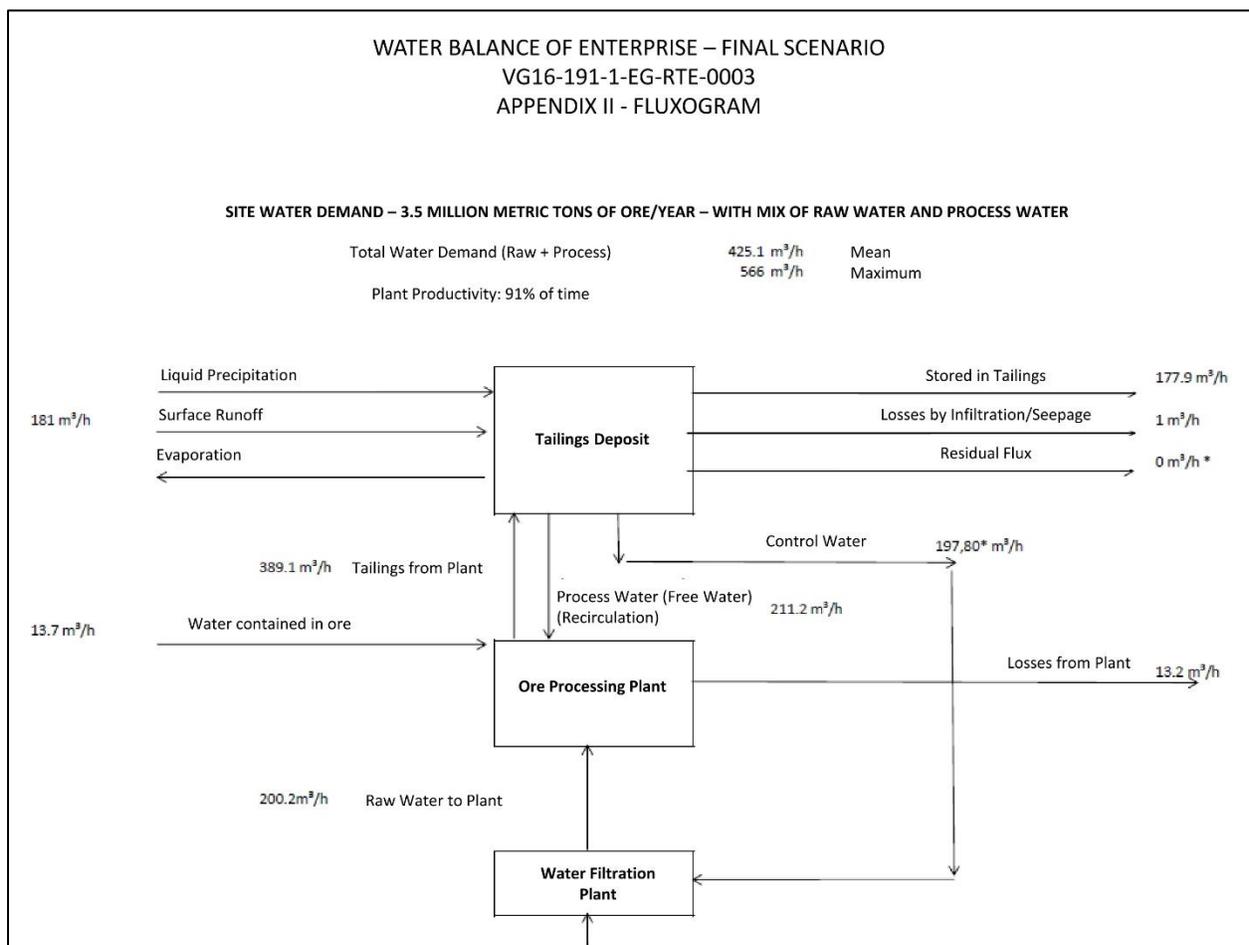
Figure 10. The mixture of tailings and water would be thickened to a 53% solids content before export to the tailings deposit. However, the addition of 181 cubic meters of water from the catchment for every 389.1 cubic meters of water from the ore processing plant would give the mixture of tailings and water an effective solids content of 43%, which is within the range for conventional tailings management with no thickening. The addition of catchment water to the tailings deposit is the opposite of the current practice of constructing diversion canals around the tailings deposit in order to prevent the entry of catchment water so as to reduce the water stored behind the tailings dam. Because of the use of cyanide in the ore processing plant, the recirculation of water from the tailings deposit has the potential to increase the concentrations of antimony, arsenic and mercury in the water with each passage through the ore processing plant. Portion of figure from VOGBR (2016b) overlain with English labels.

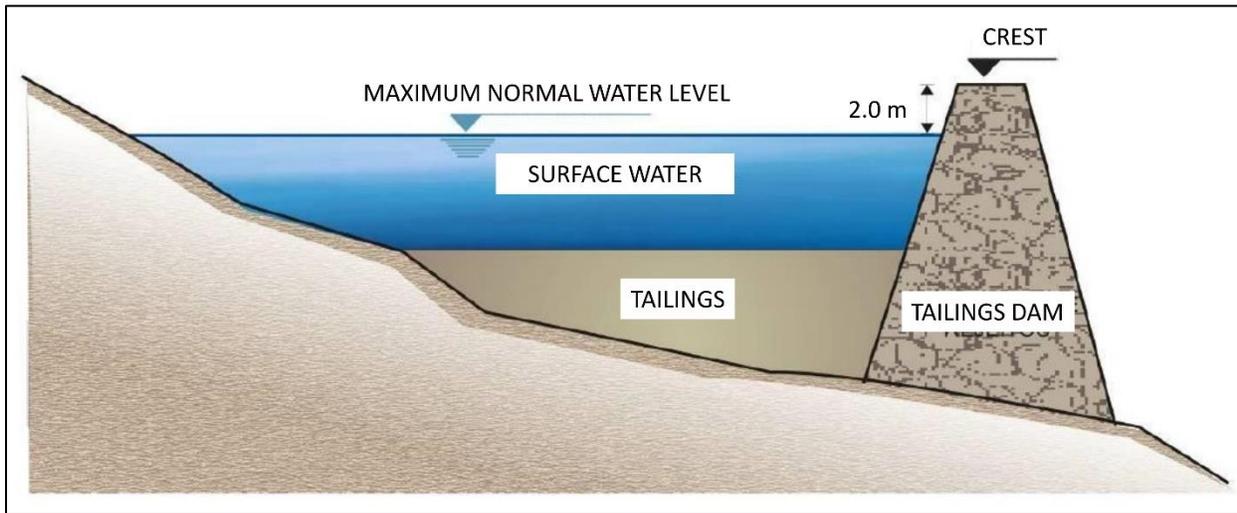
Figure 11a. The entry of catchment water into the tailings deposit and the lack of downstream discharge from the tailings dam would allow the tailings deposit to act as a reservoir of free water (water that is not stored in the pores between the tailings) for recycling into the ore processing plant (see Fig. 10). However, the result is that the tailings will be completely saturated with water. This is the opposite of the current practice of reducing the water content and lowering the water table within the tailings in order to reduce both the probability and the consequences of dam failure. Figure from VOGBR (2016b) overlain with English labels.

The use of the tailings deposit to capture surface runoff is a very unusual practice at the present time. In fact, it is far more common to construct a system of diversion channels to prevent the entry of catchment water into the tailings deposit in order to reduce the water content of the tailings (Vick, 1990). The mining company does plan to thicken the mixture of tailings and water to a 53% solids content before export to the tailings deposit. However, the addition of 181 cubic meters of water (surface runoff + precipitation – evaporation) for every 389.1 cubic meters of water from the ore processing plant (see Fig. 10) would give the mixture of tailings and water an effective solids content of 43%, which is within the range for conventional tailings management with no thickening.

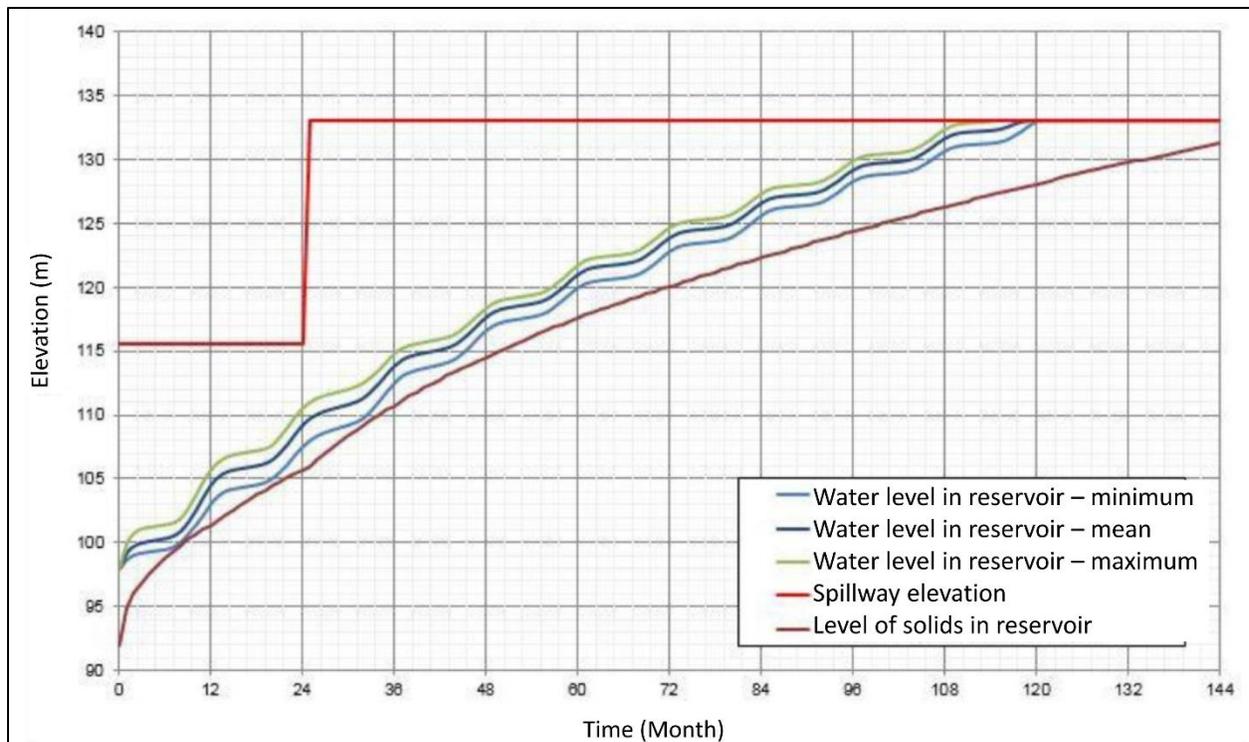
Figure 11b. The entry of catchment water into the tailings deposit and the lack of downstream discharge from the tailings dam would allow the tailings deposit to act as a reservoir of free water (water that is not stored in the pores between the tailings) for recycling into the ore processing plant (see Fig. 10). After 10 years of mining, the water level behind the tailings dam should be 7 meters above the level of the solid tailings (see Fig. 11a). The result is that the tailings will be completely saturated with water. This is opposite of the current practice of reducing the water content and lowering the water table within the tailings in order to reduce both the probability and the consequences of dam failure. Figure from VOGBR (2016b) overlain with English labels.

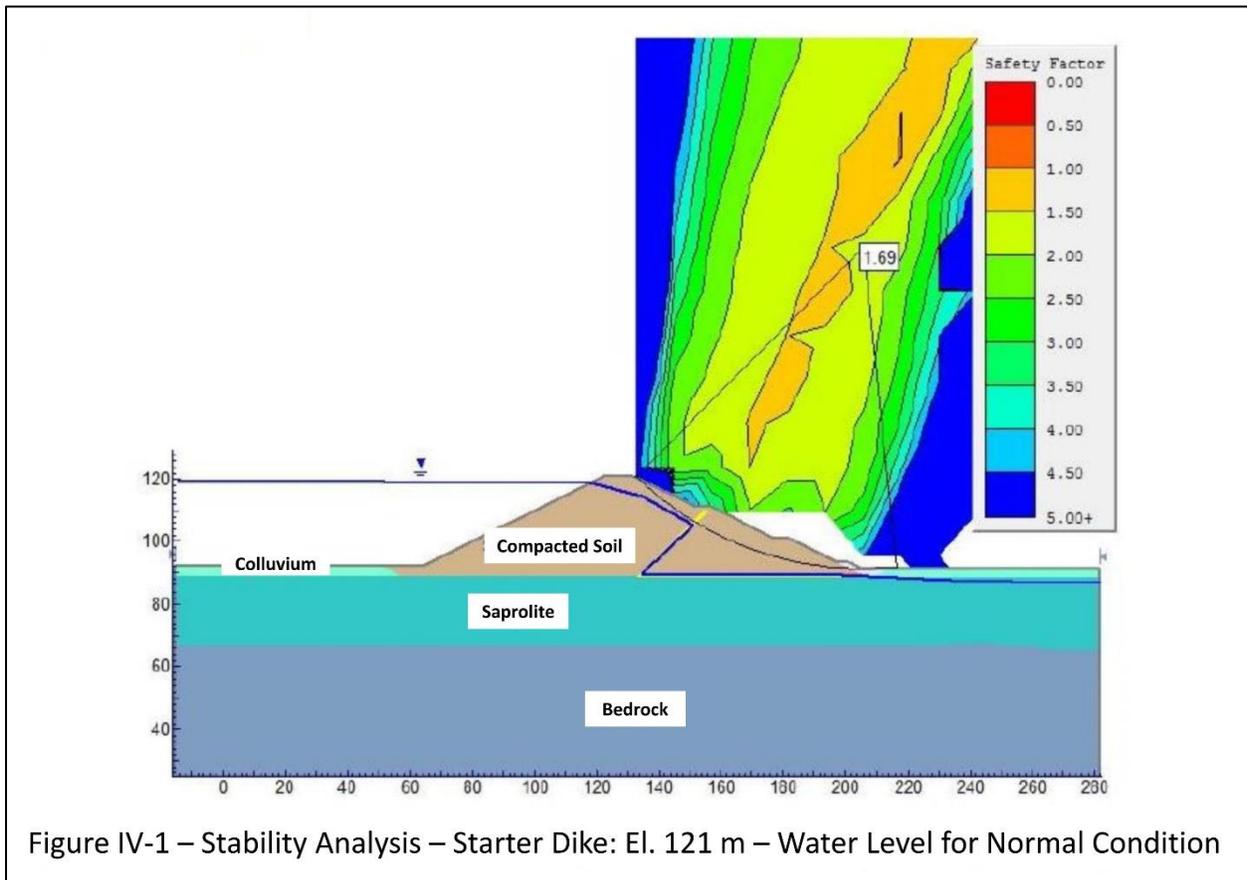
Figure 12a. The starter dike would have a factor of safety of 1.69, where the factor of safety is the minimum ratio of the shear resistance to the shear stress, considered over all possible failure surfaces. The calculated factor of safety exceeds the minimum value of 1.50 that is required by Brazilian tailings dam regulations (ABNT, 2017). However, the factor of safety was calculated only for the static condition and not for the dam response to seismic acceleration, contrary to the same tailings dam regulations that require design to withstand the Maximum Credible Earthquake (ABNT, 2017). No stability analyses have been provided for the final dike (see Fig. 8). Note the role of the internal drainage system (see Fig. 8) in lowering the water table within the starter dike. Figure from VOGBR (2016a) overlain with English labels.

Based upon the geometry of the tailings deposit, an assumed water table height, and the geotechnical parameters of the compacted soil and the foundation, the starter dike would have a factor of safety of 1.69 against failure by slumping or sliding (see Fig. 12a), which is reasonably greater than the minimum value (1.50) required by Brazilian tailings dam regulations (ABNT, 2017). The internal drainage system (yellow lines in Figs. 8 and 12a) would clearly play a critical

role in lowering the water table within the tailings dam (although not in the tailings stored behind the dam). Any failure of the internal drainage system that would allow the water table to rise about one-half the dam height on the downslope side of the starter dike would cause the factor of safety to drop below the minimum acceptable value (see Fig. 12b). I have not seen any document that carries out the same stability analysis for the final dike.

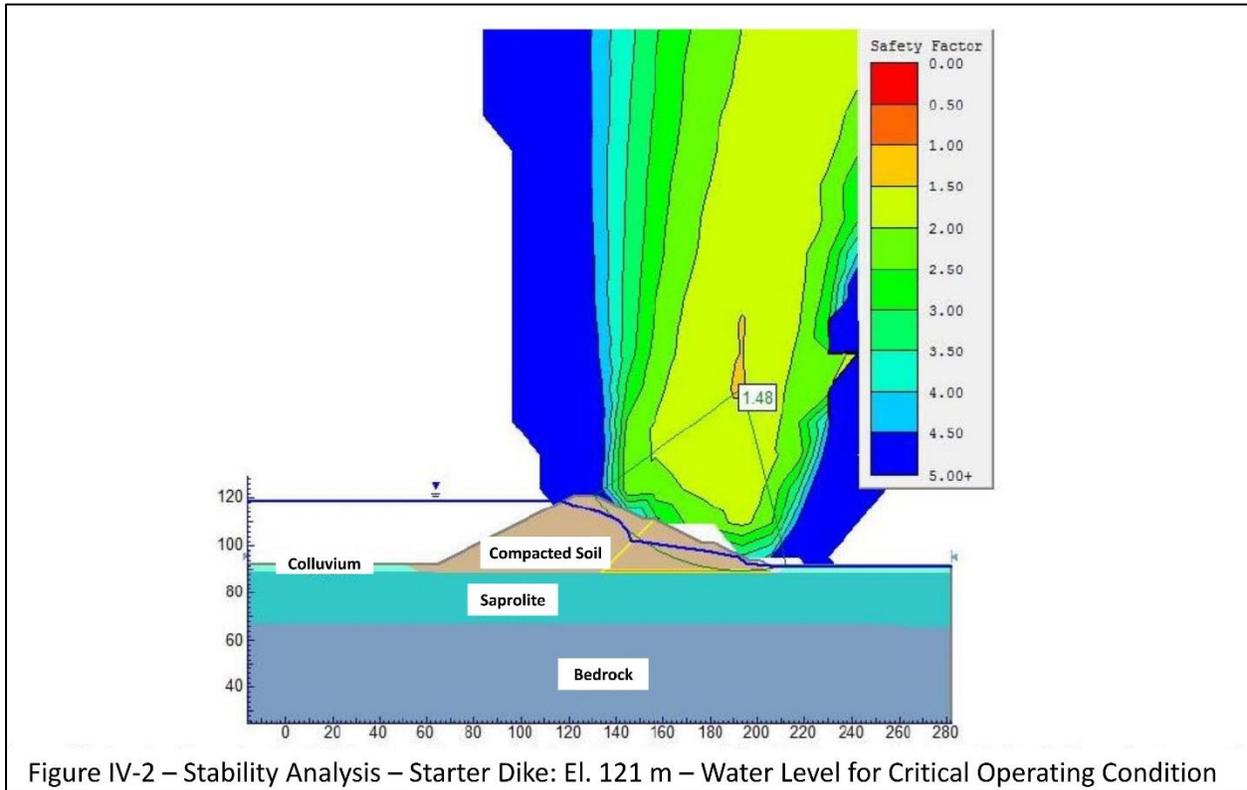
Figure 12b. The figure shows the critical level of the water table within the tailings dam at which the factor of safety would fall below the minimum value (1.50) required by Brazilian tailings dam regulations (ABNT, 2017). The factor of safety is the minimum ratio of the shear resistance to the shear stress, considered over all possible failure surfaces. However, the factor of safety was calculated only for the static condition and not for the dam response to seismic acceleration, contrary to the same tailings dam regulations that require design to withstand the Maximum Credible Earthquake (ABNT, 2017). No stability analyses have been provided for the final dike (see Fig. 8). Note the role of the internal drainage system (see Figs. 8 and 12a) in lowering or in failing to lower the water table within the starter dike. Figure from VOGBR (2016a) overlain with English labels.

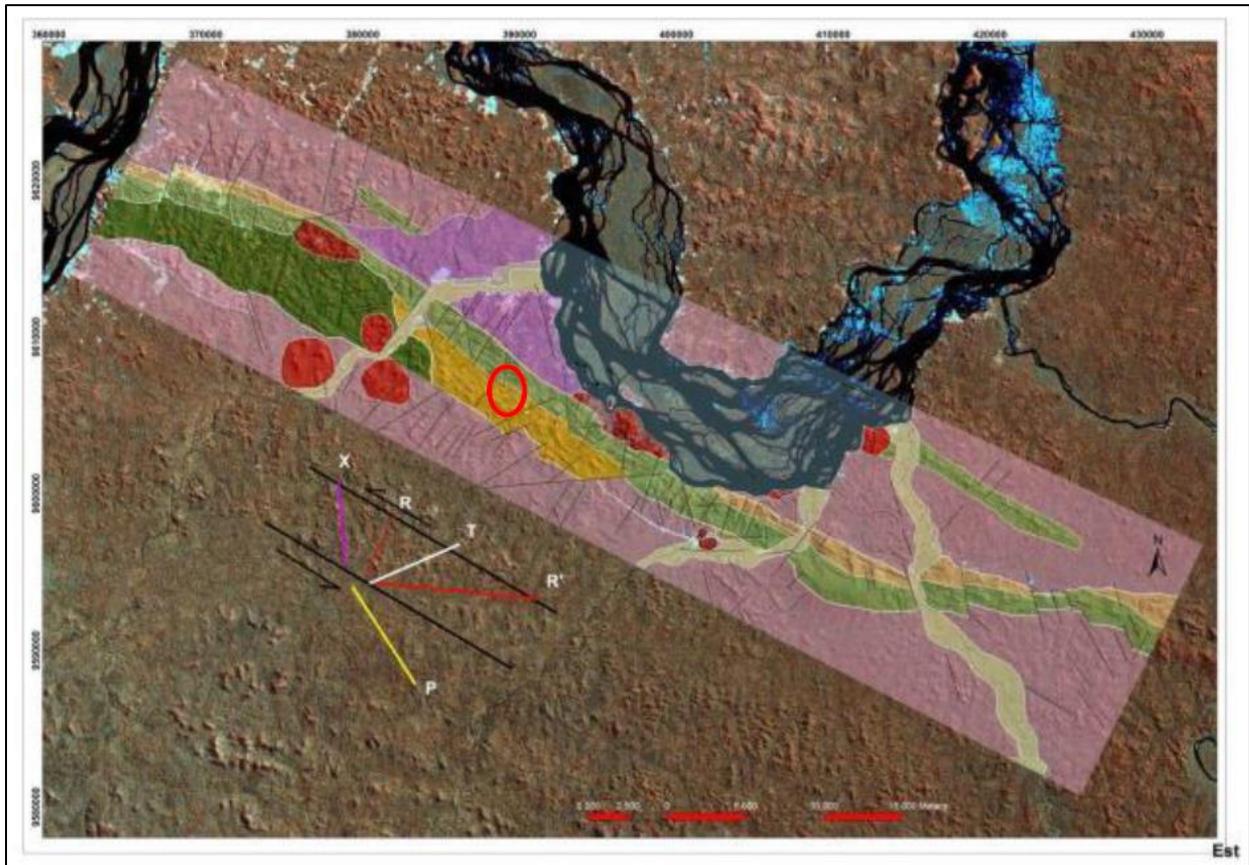
It is most disturbing that the existing stability analyses were carried out only under static conditions and not under the condition of a design seismic acceleration. In fact, none of the documents of the 2016 EIS discuss a design earthquake or include any analysis of local or regional seismicity. This is surprising because the documents show maps of faults and fractures in the vicinity of the mining project site, including three possible faults intersecting at the exact site of the proposed tailings dam (see Figs. 13a-b; VOGBR, 2016a). However, these faults were discussed only in terms of their ability to transmit seepage of water from the tailings deposit, and not in terms of their ability to act as sources of seismicity.

As mentioned earlier, this failure to carry out seismic studies and to design a tailings dam to accommodate the Maximum Credible Earthquake (MCE) is in violation of current Brazilian tailings dam regulations (ABNT, 2017). It is disturbing that, in a presentation to FUNAI

Figure 13a. A geological map superimposed onto a Landsat image shows possible faults with directions T, R, X, P and R' in the vicinity of the tailings deposit (red ellipse). (Compare with Fig. 2 for location). Although the figure was provided by VOGBR (2016a), there was no discussion of the ability of the faults to act as sources of seismicity that could impact the tailings dam. Figure from VOGBR (2016a).

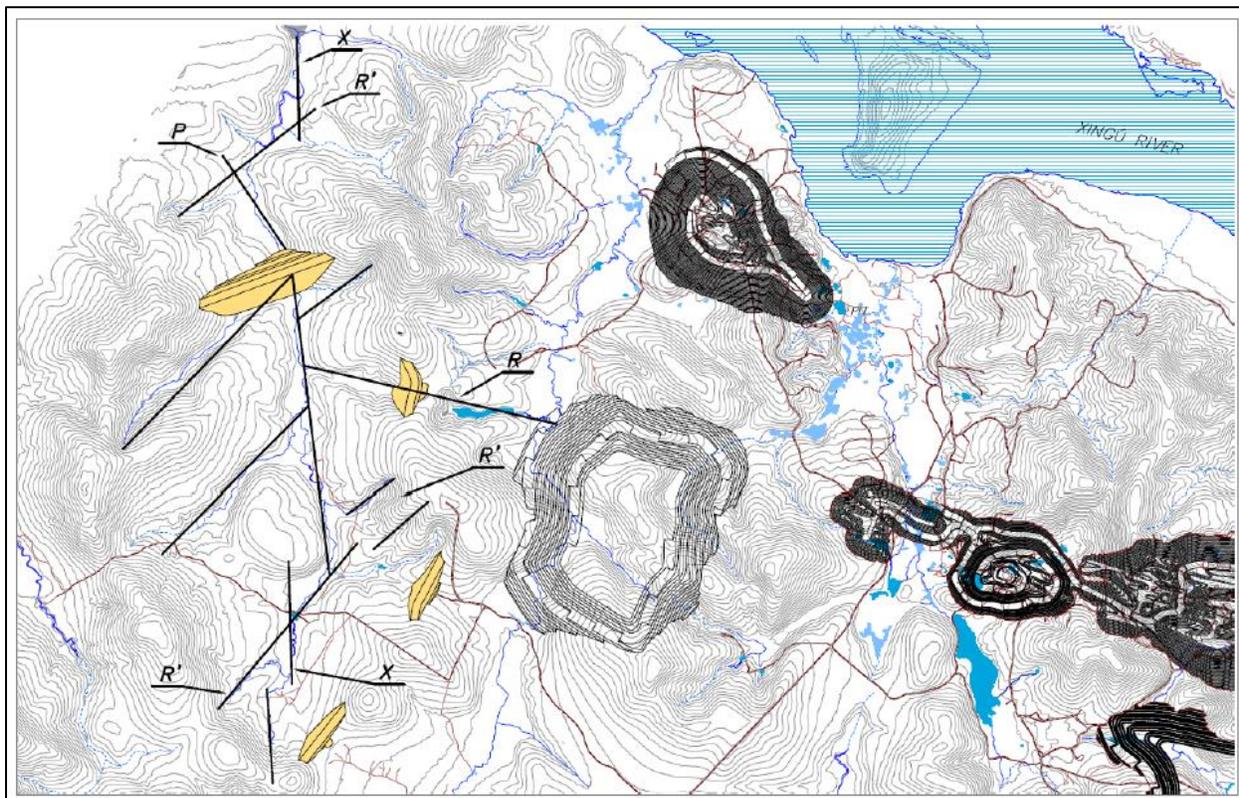
Figure 13b. VOGBR (2016a) provided a figure that showed possible faults in the vicinity of the tailings dam, but did not discuss the ability of the faults to act as sources of seismicity that could impact the tailings dam. The large yellow polygon is the principal tailings dam, while the three smaller yellow polygons are dikes around the perimeter of the tailings deposit. (Compare with Fig. 3 for location). Figure from VOGBR (2016a).

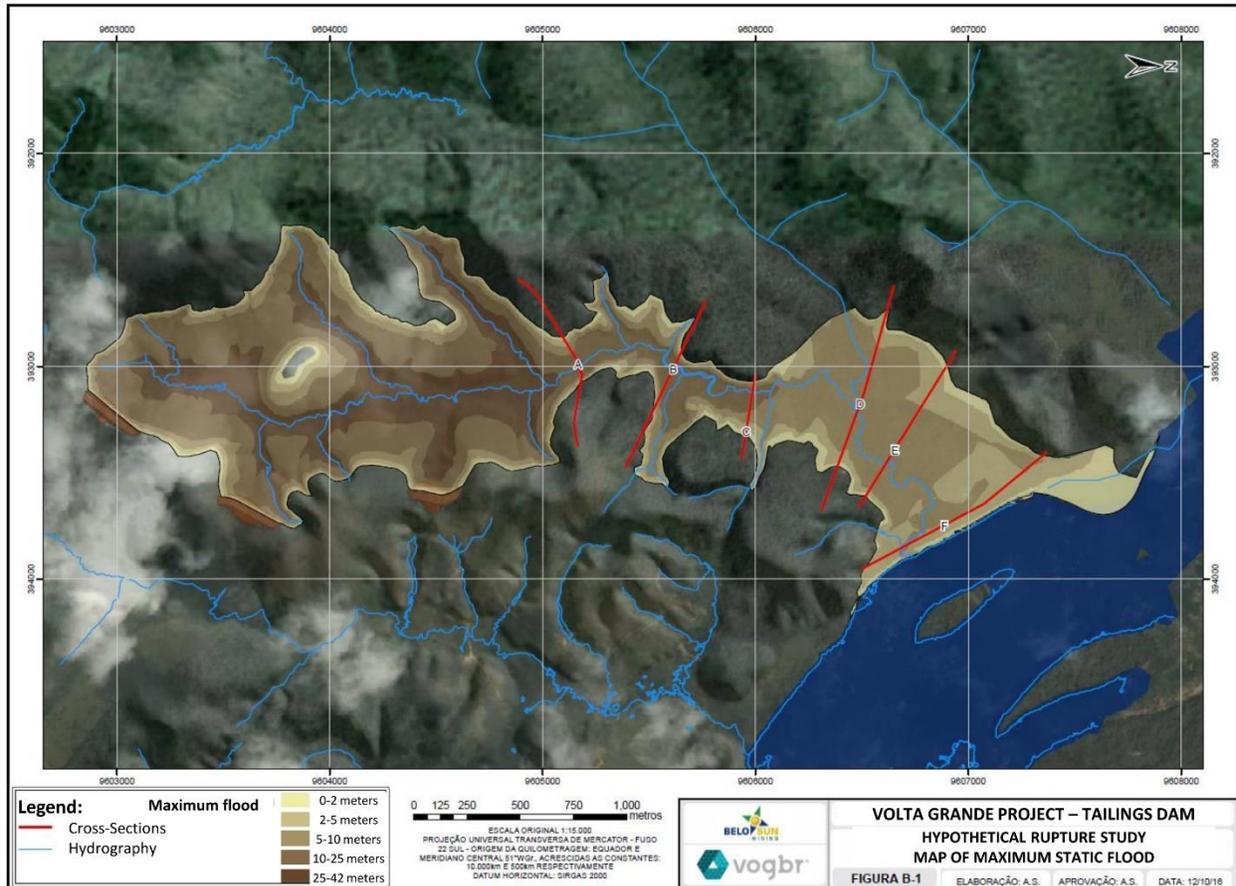
Based on a dam height $H = 44$ meters and a volume of stored tailings and water $V_T = 35.43$ million cubic meters, Eqs. (1)-(3) predict a spill volume $V_F = 9.84$ million cubic meters (27.8% of the stored tailings and water) and an initial runout of 41.4 kilometers along the Xingu River (see Fig. 2). The above is the most-likely scenario following dam failure and it would certainly impact the indigenous land of the Arara de Volta Grande do Xingu (see Fig. 2). The worst-case scenario would be the spill of 100% of the stored tailings and water, which would result in an initial runout of 98.1 kilometers along the Xingu River according to Eqs. (3)-(4). Subsequent to the initial event, normal fluvial processes would continue to transport the spilled tailings farther down the Xingu River into the Amazon River and eventually into the Atlantic Ocean (see Fig. 1).

The time scale of the above events is also a matter of concern. Although the edge of the tailings deposit is 1535 meters from the banks of the Xingu River, the tailings flood would more likely flow along an existing stream channel for 2228 meters before reaching the Xingu River (see Fig. 3). There have not been many measurements of the velocities of tailings flow slides, but they have ranged from 20-160 kilometers per hour (Jeyapalan, 1981). According to Petley (2019), the tailings flow slide following the 2019 failure of the tailings dam in Brumadinho, Minas Gerais (see Table 1) accelerated to 120 kilometers per hour and then slowed to 66 kilometers per hour. The lower limit of 20 kilometers per hour apparently accounts for the new mining legislation in Minas Gerais that prohibits the construction or expansion of a tailings dam where there is a population residing either 10 kilometers downstream of the dam along the course of the valley or within the zone that could be reached by the tailings flood within 30 minutes, whichever is farther (Assembleia Legislativa de Minas Gerais, 2019). Using the most conservative value of 20 kilometers per hour, the tailings flood from a failure of the tailings dam would arrive on the banks of the Xingu River in under 7 minutes, and would cover the initial runout (41.4 kilometers), reaching and passing the indigenous land of the Arara de Volta Grande do Xingu, in about two hours (see Fig. 2).

Figure 14. The dam break analysis was flawed in that it assumed that the tailings flood would cease when the tailings reached the Xingu River (Brandt Meio Ambiente, 2016). Cross-section A is the edge of the tailings dam (compare with Fig. 3 for location, but note difference in north arrows). The figure is overlain with English labels and comes from a report that was not available to the author.
